Navajo Abandoned Uranium Mine Site Screen Report

Francis AUM Site

Navajo AUM Eastern Region

May 2009

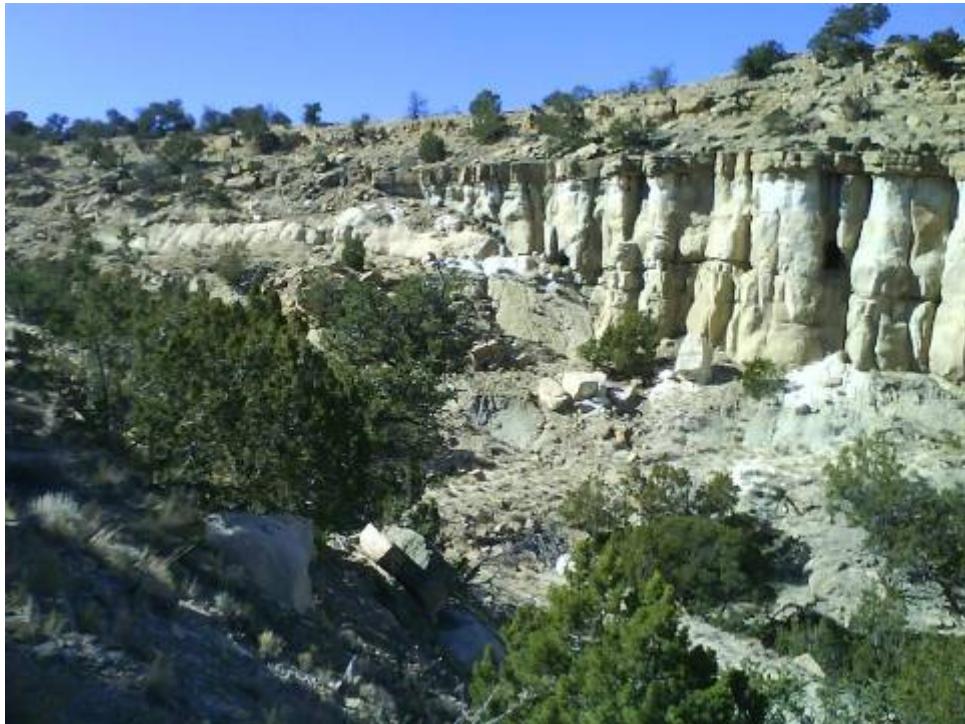
Photo 1. Francis Mine site, towards the west

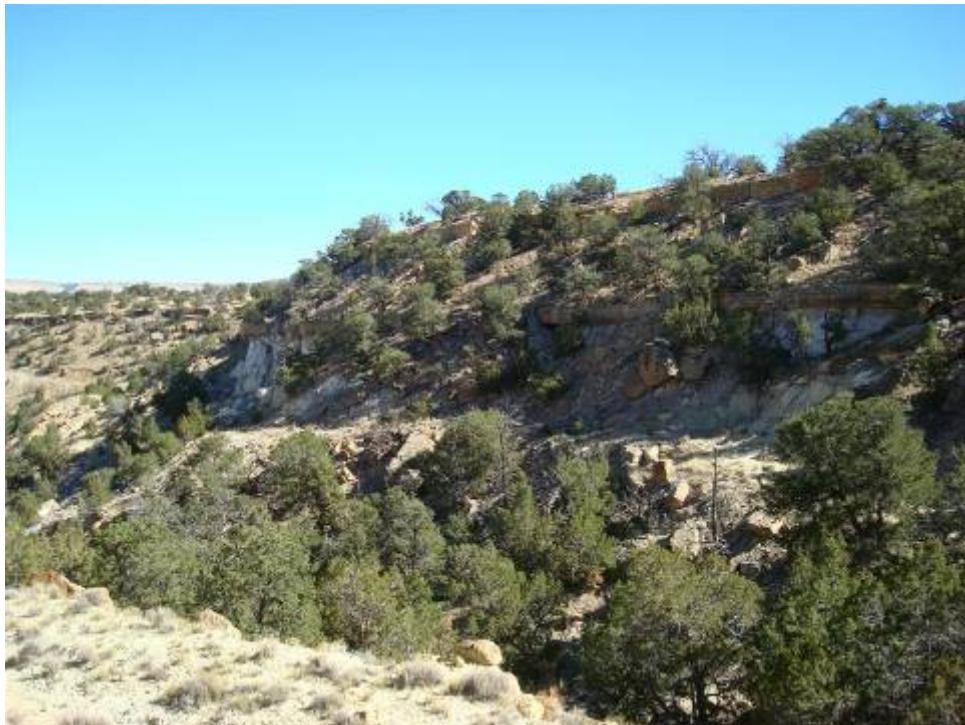
Photo 2. Francis Mine site, towards the east

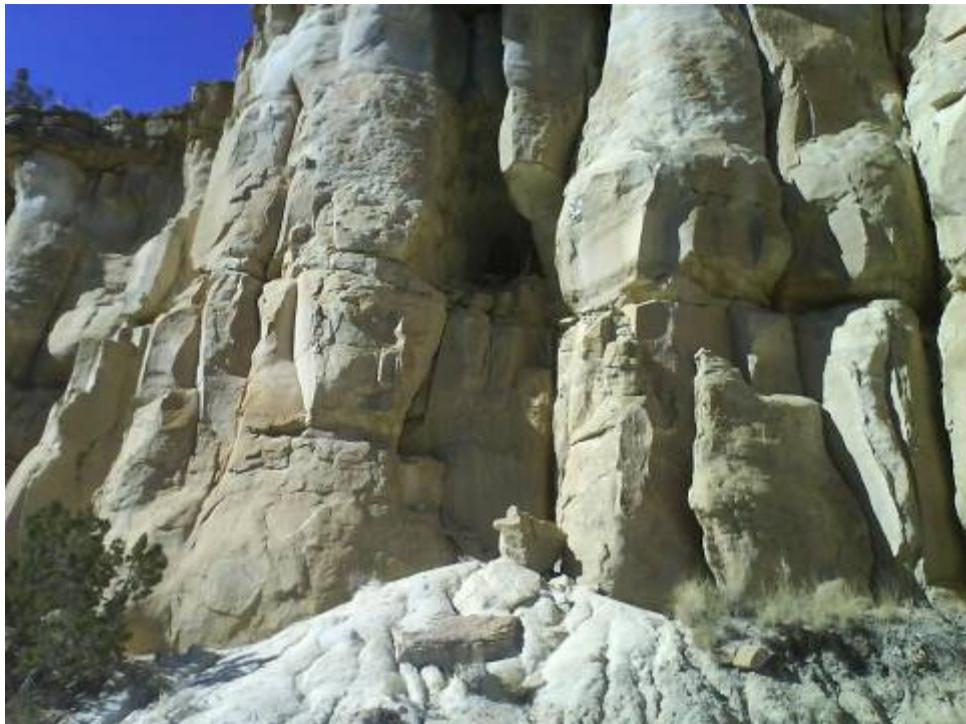
Reclamation status of the mine sites are currently unknown. No visible signs of reclamation were observed. The mine is located in a canyon with steep bluffs. Three adits were observed located in bluffs at the mine, one of which was located approximately 25 feet up the vertical bluff with waste rock piles below. No other mine features were observed during the site visit.

Photo 3. Francis Mine site, adit and waste rock pile

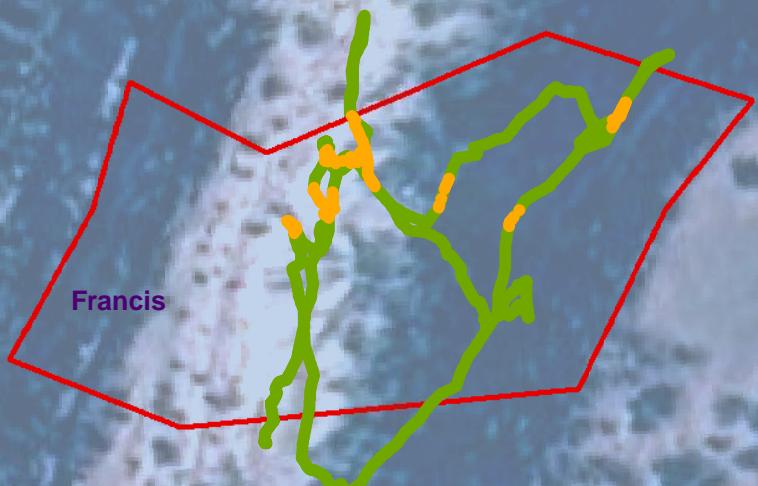
Figure 1

A total of 1,710 gamma radiation measurements were collected from the mine site, ranging from 8,107 cpm to 158,906 cpm. The measurements are represented in Figures 1 and 2.

Gamma survey conducted in October 2008
measured as counts per minute (cpm)
Average background = 13,400 cpm

Gamma Radiation Measurements
Above Two Times Background
Francis
Baca/Haystack Chapter
Navajo Nation, New Mexico
